PRODUCT NOTICE — SNAPHOOKS

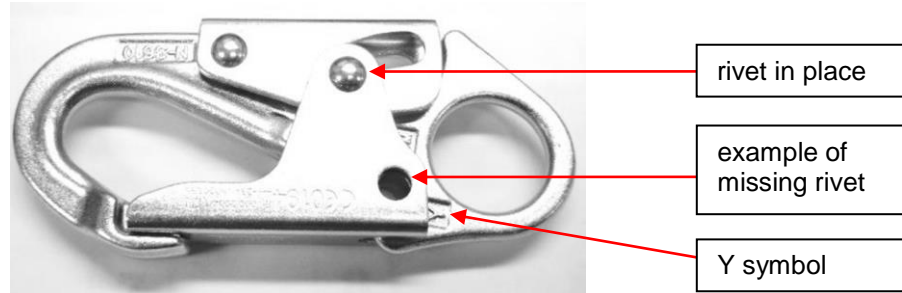
Capital Safety is aware of an assembly issue with snaphooks manufactured by a supplier. These snaphooks are widely used components in fall protection products. The issue concerns missing or improperly installed rivets (see photograph below). The manufacturer symbol is a stamped “Y” as shown in the photograph.

The picture above is a representative model snaphook – other models are also affected.

Capital Safety has verified that the supplier implemented an appropriate corrective action program. The supplier’s notification (above) has an imbedded video demonstration of its revised process.
