PRODUCT NOTICE — SNAPHOOKS

Capital Safety is aware of an assembly issue with snaphooks manufactured by a supplier. These snaphooks are widely used components in fall protection products. The issue concerns missing or improperly installed rivets (see photograph below). The manufacturer symbol is a stamped “Y” as shown in the photograph.

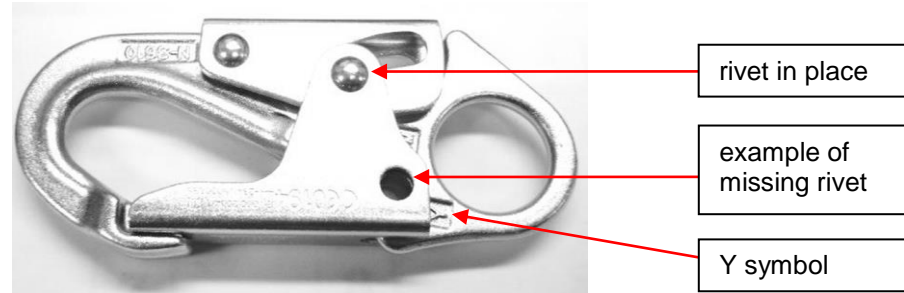
The picture above is a representative model snaphook – other models are also affected.

Capital Safety has verified that the supplier implemented an appropriate corrective action program. The supplier’s notification (above) has an imbedded video demonstration of its revised process.

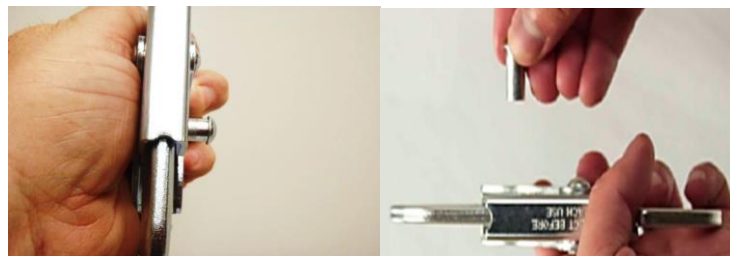
Figure 1: Loose rivet may protrude from hook.

Figure 2: Loose rivet can separate from hook.

We want to remind users to conduct a pre-use inspection of all fall protection safety equipment prior to use as per instructions in the user manuals. If a missing or incompletely installed rivet is identified in a snaphook on a Capital Safety product, the product should be removed from service and returned via distribution for replacement under warranty. (See figure 1 & 2 below.)
