FIXED BEAM ANCHOR - INSPECTION NOTICE (FOR SALT-WATER/CHLORIDE/SULFIDE ENVIRONMENTS)

The DBI-SALA Fixed Beam Anchor is an anchorage connector for a personal fall arrest system. It is designed to be attached to an I-beam. Capital Safety's user manual warns about "Environmental Hazards" and that certain chemicals and corrosive environments may damage the equipment.

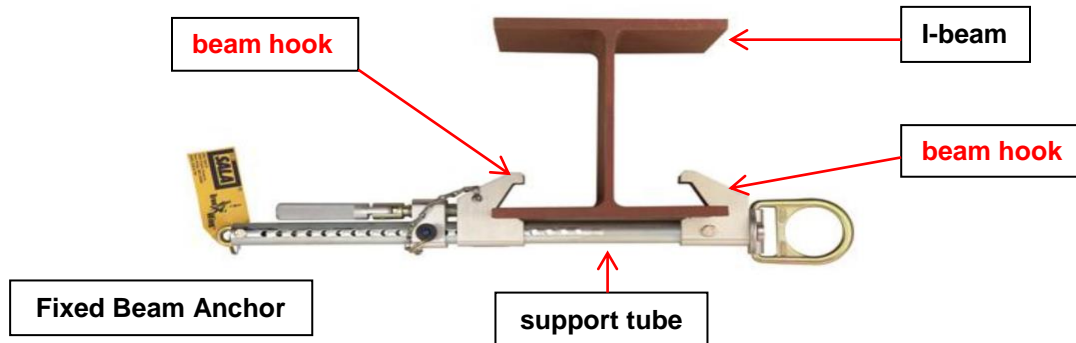
Capital Safety has become aware that the service life of the beam hooks identified in the images below (in red font) may be impaired by stress corrosion cracking when the anchor is exposed to salt-water or other chloride or sulfide-containing environments.

This is not a product recall. If you have these units deployed in salt-water or other chloride or sulfide-containing environments, and if you purchased the units prior to January 1, 2014, we recommend you:

- 1) have the units visually inspected by a competent person; and
- 2) if **any** corrosion, pitting or cracking is found on the beam hooks or the support tube (see illustrations below), remove the unit from service and return via your supplier/distributor to Capital Safety for evaluation and potential replacement under warranty at Capital Safety's reasonable discretion and expense.

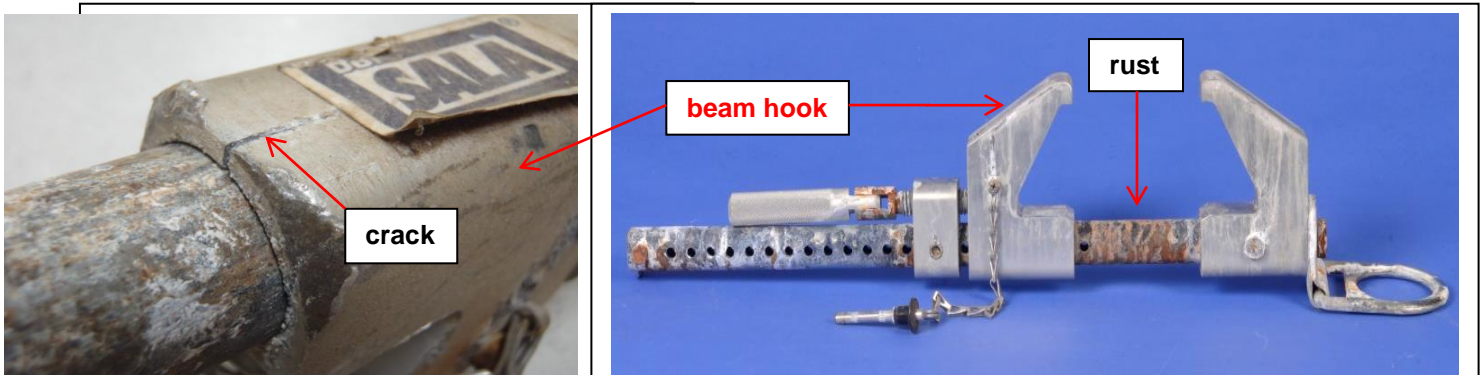
Illustrative images: cracks or rust may look different or be in different locations

- 3) if **no** corrosion, pitting or cracking is found on the beam hooks or the support tube, the units are safe to remain in service provided they are inspected every 90 days and removed from service if **any** corrosion is found anywhere on the unit.

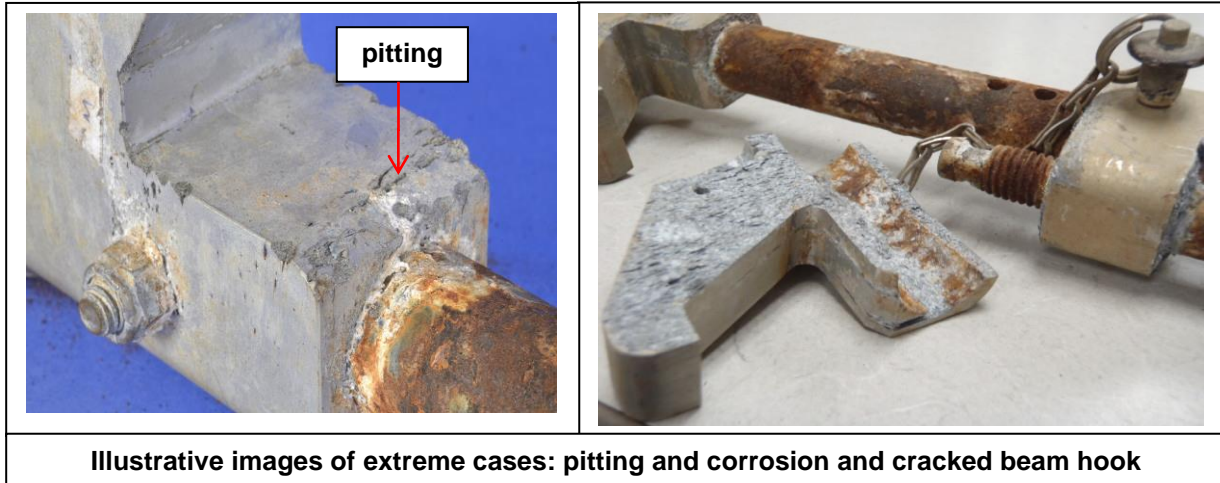
In extreme cases, the integrity of the beam hooks can be severely compromised to the point of failure by stress corrosion cracking as seen in the photographs below:

Since becoming aware of this issue, Capital Safety has changed the metal alloy of the beam hooks to make them resistant to stress corrosion cracking in salt-water or other chloride or sulfide-containing environments.

Capital Safety has also revised its User Manual concerning inspection as follows: ***“IMPORTANT: Any observed corrosion or rust on the anchor is a potential safety concern because it can weaken the product and create a risk of injury or death to workers. Any anchor showing signs of corrosion or rust should be removed from service immediately.”***
